## **Former Brickworks Wall**

Ira Street.

### **Summary of heritage significance**

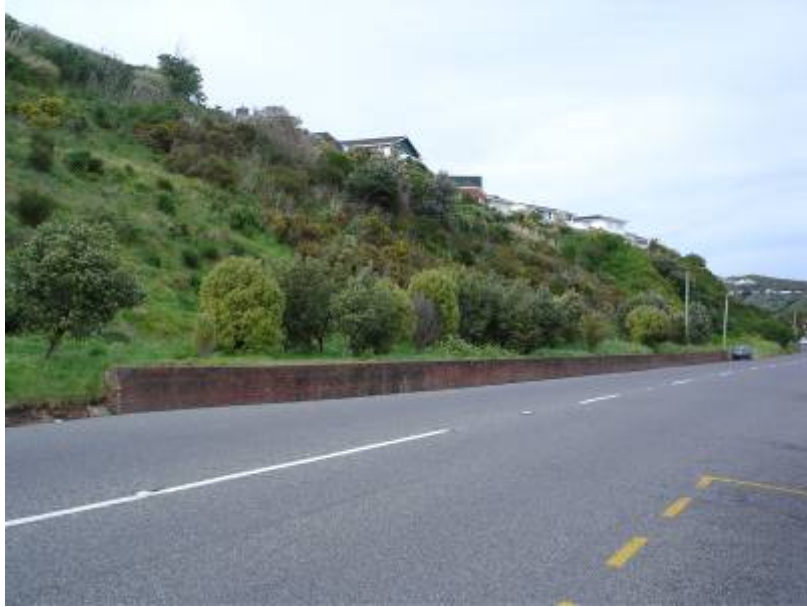
Image: Googlemaps 2013

The Ira Street Brick Wall is constructed of fired clay bricks, 10 courses high, with two rows of bricks on edge (with bull nosed corners) on top. The bricks are laid in English Garden Wall bond, with a course of headers (bricks laid end on to the face of the wall) laid between every three courses of stretchers (bricks laid side on). There are rectangular weep holes placed at intervals along the bottom course, with several clay pipes protruding about halfway up the wall. The bricks are laid with a cement mortar, which is still in good condition, and the whole wall rests on a concrete foundation. The northern end of the wall is roughly finished, as approximately six metres of the wall has been demolished at this end; the southern end is cleanly finished, indicating that this was the original end of the wall. The wall is in good condition with no significant cracking or subsidence.

This brick wall, while rather unassuming, is a physical link to the history of the area and the only remnant of Miramar's brick making past. It is in good condition with no significant cracking or subsidence and has technical value as a well built, authentic example of brick wall construction.
