## Commercial Building

88 Manners Street

### Summary of heritage significance

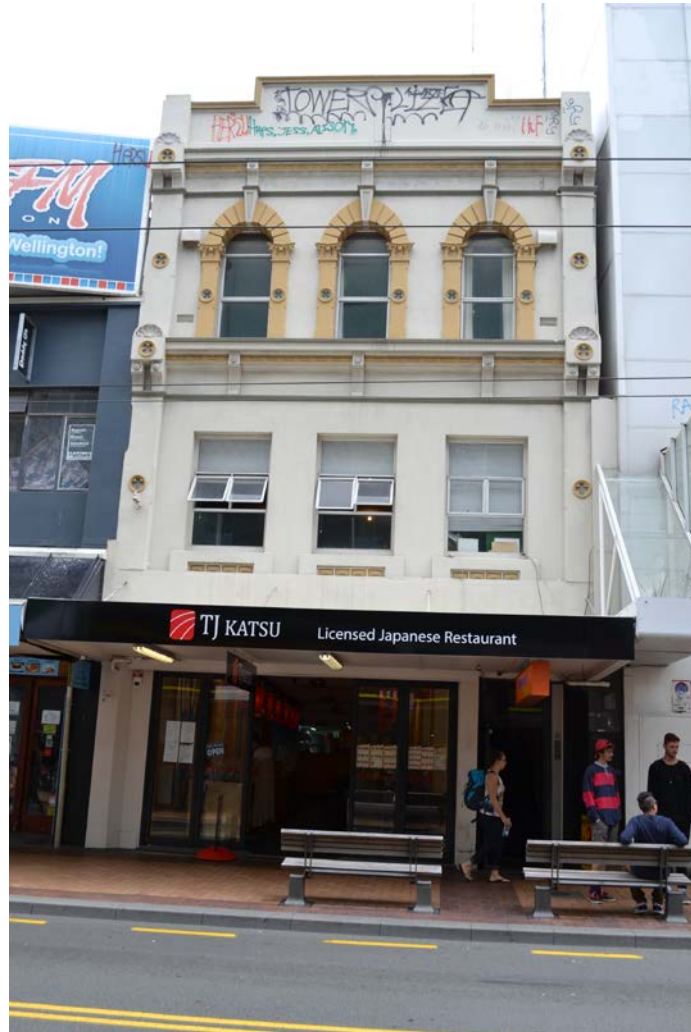
Photo: *Charles Collins, 2015*

- This building is a good example of an Edwardian commercial building with a well proportioned façade that features some elegant Classical detailing.
- This building is an important part of the Manners streetscape and makes a contribution to the setting of Manners, Cuba, and Dixon streets, and more widely Courtenay Place where more buildings of this type survive. It contributes significantly to the sense of place and continuity in the central city as one of the few early twentieth century buildings on this part of Manners Street.

The building exterior is an odd mix of old and new – and this can best be described in terms of the difference between the 1908 drawings as proposed, and the building we can see today. The ground floor shop-fronts have been replaced. The second floor façade is generally as drawn in 1908, but the first floor façade has been simplified and the windows have arched rather than square heads. The stepped parapet was rebuilt in 1944 as part of repair work following the 1942 earthquake. These changes were made to the designs of architectural firm Gray Young, Morton, and Young.<sup>3</sup> The elaborate parapet finials or urns have not survived (or were never built).
